RURAL NONPOINT SOURCE POLLUTION BEST MANAGEMENT PRACTICES (BMP) ROADBANK/STREAMBANK CONSTRUCTION

Project Description: The majority of sediment pollution in Onondaga Lake is attributed to Onondaga Creek and its tributaries, primarily due to streambank erosion and mudboils. The main focus of this project is to reduce stream bank and channel erosion, thereby reducing the amounts of sediment in the creek that would enter Onondaga Lake. This work is being completed by using several different stabilization techniques, including the following:

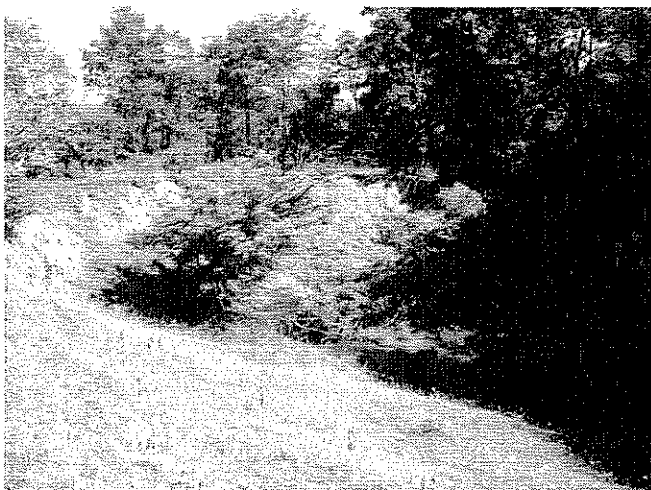
Before Construction - Severe Erosion, 24-foot Vertical Bank.

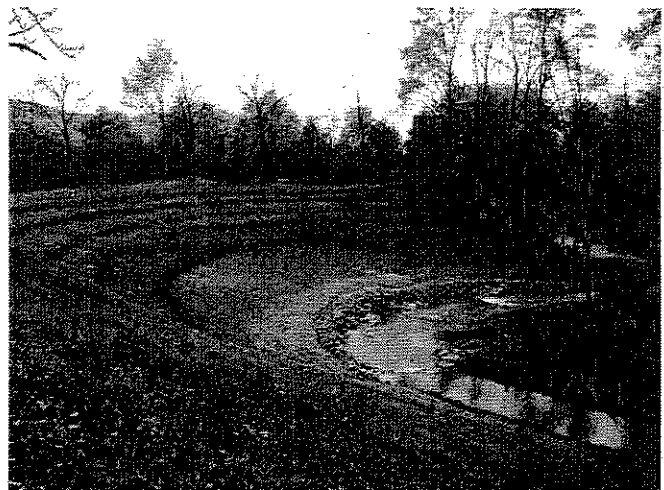
After Construction - In-stream Structures and Soil Bioengineering.

- **J-Hook** - A structure located in the stream channel, consisting of a line of rock that points upstream and slopes down in elevation towards the center of the stream channel. J-hooks are installed at the outside of stream bends and direct the main stream flow into the center of the stream.

- **Crossvane Weir** - Another in-stream structure, the weir is a "V" shaped rock configuration, with the point of the V facing upstream. Crossvanes are installed in straight stretches of the stream and are used for grade control.

- **Soil Bioengineering** - The use of living plants and their roots to bind the soil together, providing a resistance to erosion. All disturbed areas were immediately seeded

and mulched; then in the following spring, planted with shrubs and trees. The techniques that were used are live stakes, brush layering and fascines plantings to stabilize the soil. Live stakes are shrub stems about 1-2 inches in diameter and 3 feet long. These are inserted into the soil and the entire stem develops roots which will stabilize the soil. Brush layering involves installation of many branches into a trench on the contours of steep slopes. Fascines are branches tied together in an 8-inch diameter bundles, which are then buried in the soil on contours. This creates a vegetated wall which reduces stream velocities. The plants used are quick growing, wet footed species that will hold the soil in place after one year's growth.
